# CLEARINGHOUSE TYPE SYSTEM AND DATABASE FOR POST-SEISMIC BUILDINGS ASSESSMENT

## ABSTRACT

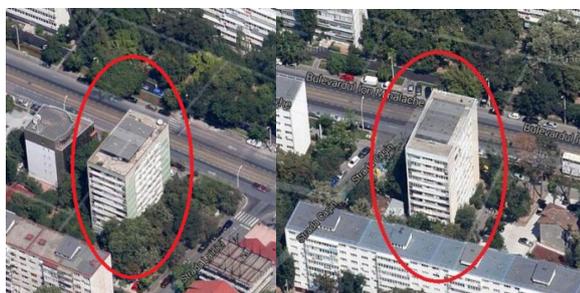
**Fig. 4.** Images of two buildings: Block of flats No.16 and Block of flats No.21

The buildings shown in Figure 4 were designed and erected in the years 1970's,

consequently these buildings were subjected to Romanian earthquakes of 1977, 1986, 1990 and 2004. The buildings have the same height level of ten stories and a reinforced concrete structure.

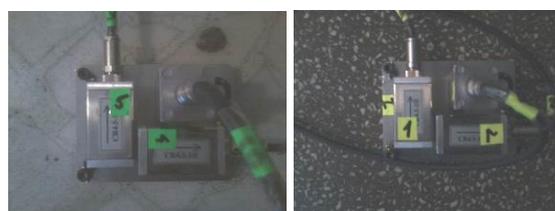
**Fig. 6.** Triaxial sensors location on vertical direction (Sensor II – Ground floor, Sensor I – storey II)

It is worth of mentioning that the recordings were made after two axial sensor placement schemes: one horizontal direction (Figure 5) and the other in the vertical direction (Figure 6).
